# FUTURE FISHERIES IMPROVEMENT PROGRAM

## BIENNIAL REPORT

Summary of program activities for the period November 1, 2016 to October 31, 2018

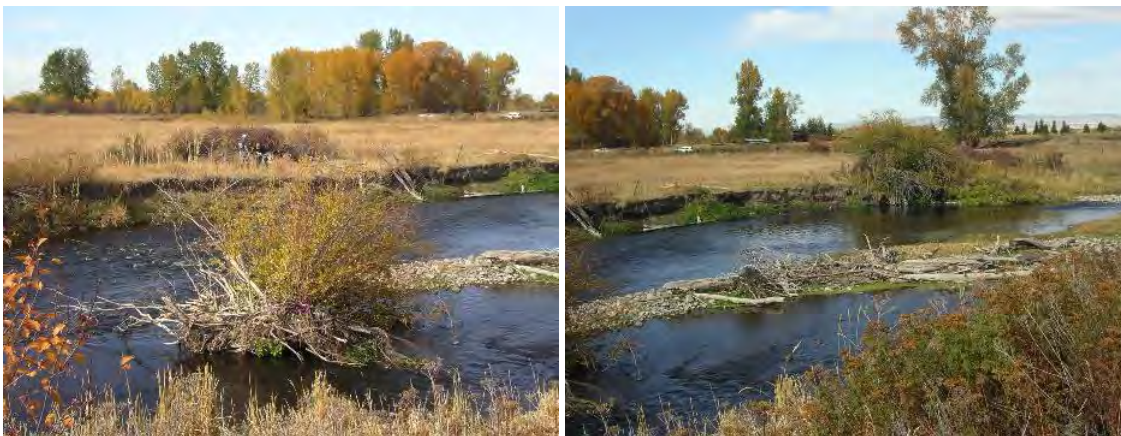
Patrick Byorth, now with Trout Unlimited, was the FWP biologist managing this project, and he provided photos and project background. The goal of this project was to provide a showcase for alternatives to bank armoring. The project occurred along three eroding banks on a single property. These vertical, eroding banks were retreating rapidly and threatening a bridge and buildings. The fluvial processes resulting in shear stress on banks varied among the banks. For banks 1 and 2, a mid-channel bar was diverting flood flows into these banks, in what was an otherwise straight reach (Figure 46). This mid-channel bar was recontoured with the intent of restoring riffle/pool periodicity and improving sediment transport.

**FIGURE 46. MID-CHANNEL BAR THAT WAS EXERTING PRESSURE ON BANKS 1 AND 2 ON THE EAST GALLATIN RIVER.**

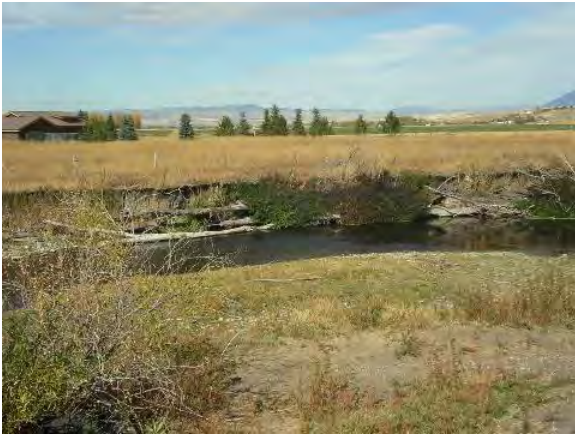
The third bank was on the outside of a meander bend and had vertical, eroding banks with slight protection afforded by woody debris and sparse shrubs. The cottonwoods were from an earlier attempt to stabilize this reach by anchoring large wood into the bank. Much of the large wood had been swept away, and the bank was laterally mobile.

**FIGURE 47. BANK 3 ON THE EAST GALLATIN RIVER, SHOWING CABLED-IN COTTONWOODS THAT WERE PART OF AN EARLIER BANK STABILIZATION EFFORT.**

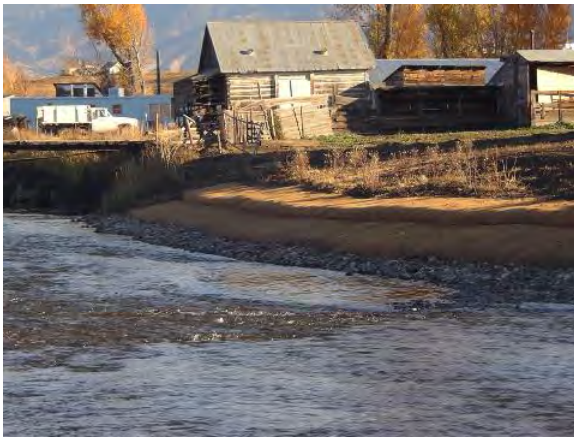
**FIGURE 49. EXAMPLE OF FABRIC-ENCAPSULATED SOIL LIFTS ON BANK 2.**

The second bank was treated with soil lifts encapsulated with erosion control fabric, revegetated, and cobbles large enough to be mobilized by a 50-year recurrence interval flood were placed at the toe of the bank. This treatment resulted in conditions like the first bank, with a bank angle of 90°, banks stabilized with grasses and sedges. The erosion control fabric decomposed with establishment of vegetation, and according to the landowner, the fabric has not been visible in years (Figure 53). Like the first bank, the rock toe had been transported away, resulting in an undercut bank.

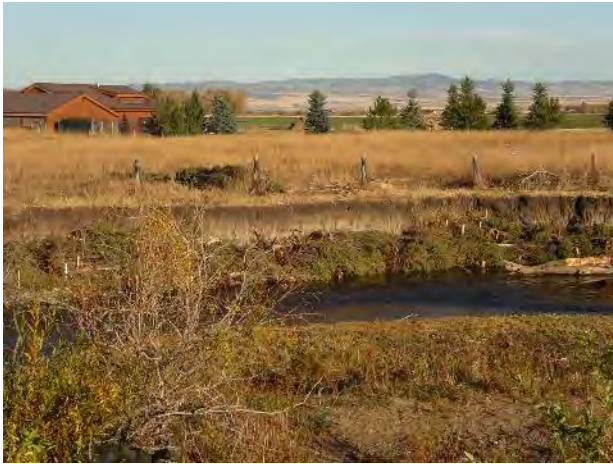
Earlier efforts to stabilize this bank entailed cabling large cottonwood trunks into the shoreline. Some cottonwoods were still in place and had slowed the bank erosion to a limited extent, but additional treatment was considered necessary to reduce flow velocities at the bank interface. The bank treatment entailed attaching juniper revetments to the existing cottonwood bank treatments. Revetments were commonly used in the 1990s and early 2000s. The conceptual approach was to provide bank protection and increase roughness, which would trap sediments, allowing banks to build on the installed features.

**FIGURE 50. JUNIPER REVETMENTS CABLED INTO BANK 3.**

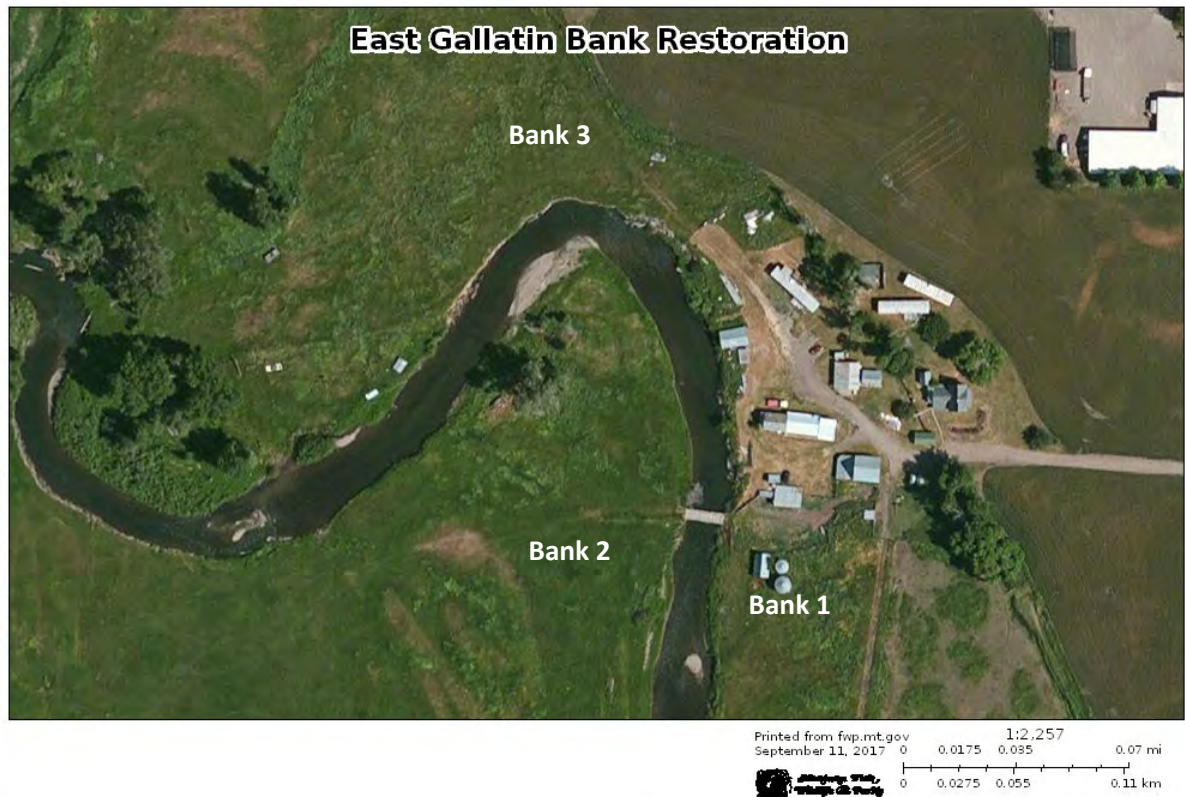
On June 29, 2017, Kyrsten Wolterstorff visited the project site, accompanied by a landowner. She evaluated the condition of the three treated banks and received insight from the landowner, who was a collaborator on the project and watched the performance of the 3 approaches to bank restoration since project implementation in 2002. An aerial view of the project area is informative in evaluating the response of the channel and stream banks to the different bank restoration approaches (Figure 51).

**FIGURE 51. AERIAL VIEW OF THE PROJECT AREA SHOWING LOCATIONS OF THE THREE TREATED BANKS.**

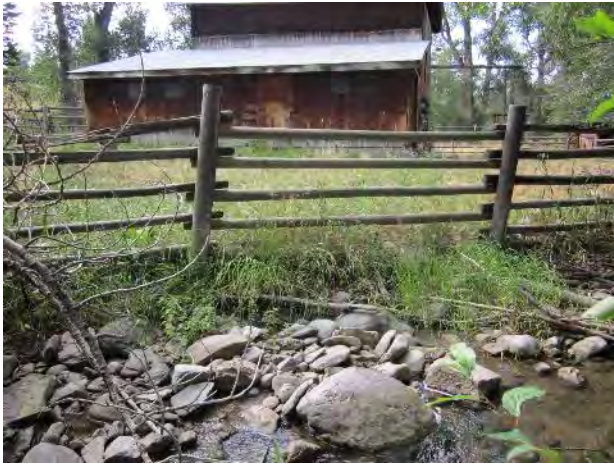
On August 16, 2017, Kyrsten Wolterstorff visited the Elk Spring Creek bypass project. She noted that fencing to protect Elk Creek had been installed, and although in slight disrepair, it was functioning to control livestock's access to the stream channel (Figure 56). The riparian area supported abundant shrubs, and all age classes of shrubs were present. This area appears to be the 50-ft. buffer between the corrals and Elk Creek mentioned in the application that was to filter runoff from the area of animal concentration.

**FIGURE 56. RIPARIAN FENCING LIMITING LIVESTOCK ACCESS TO ELK CREEK AND THE BUFFER STRIP BETWEEN THE CORRALS AND SURFACE WATER.**

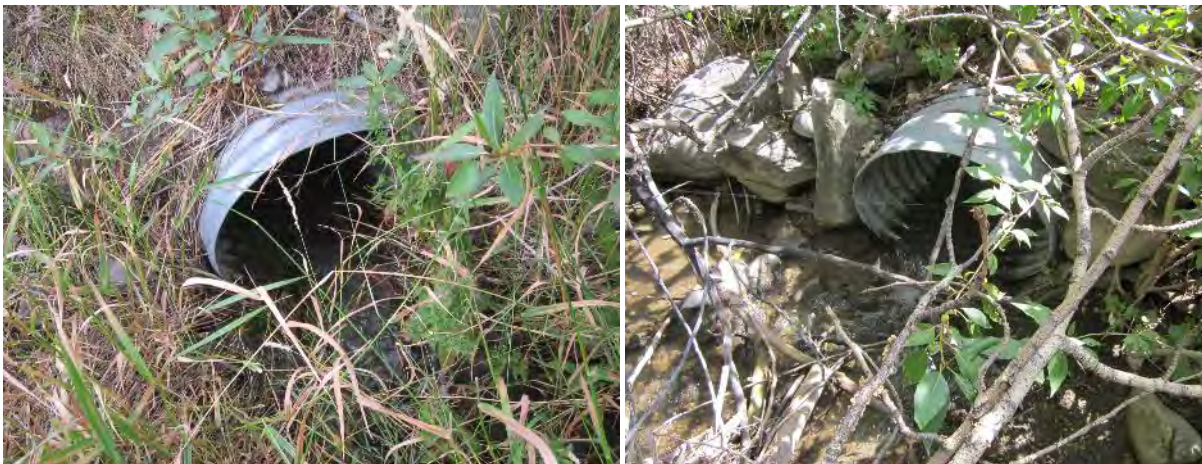
Kyrsten verified the stream had been piped under the corrals, and that alternative stock water had been provided. The inlet and outlet of the pipe were easily located (Figure 57). In addition, the stock water component of the project had been installed (Figure 58), and cattle no longer relied on surface water, which eliminated bank trampling and near-stream sources of sediment and nutrients. The operator reported the waterer occasionally clogged, but regular maintenance easily remedied this problem.

**FIGURE 57. INLET OF PIPE THAT PASSES THE UNNAMED SPRING CREEK UNDER THE CORRALS ADJACENT TO ELK CREEK (L) AND OUTLET OF PIPE (R).**

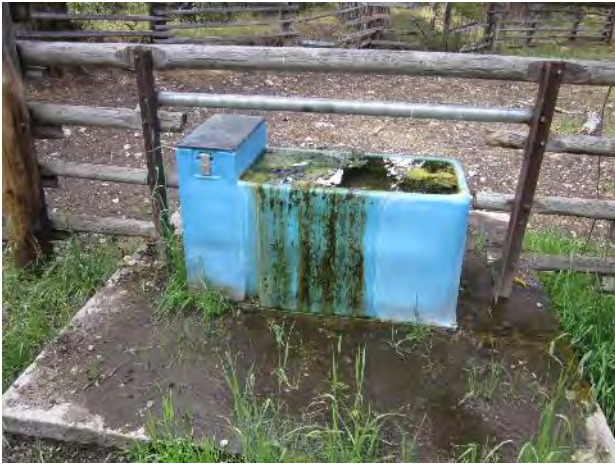
**FIGURE 58. OFF-STREAM STOCK WATER OF THE ELK CREEK SPRING CREEK BYPASS PROJECT.**

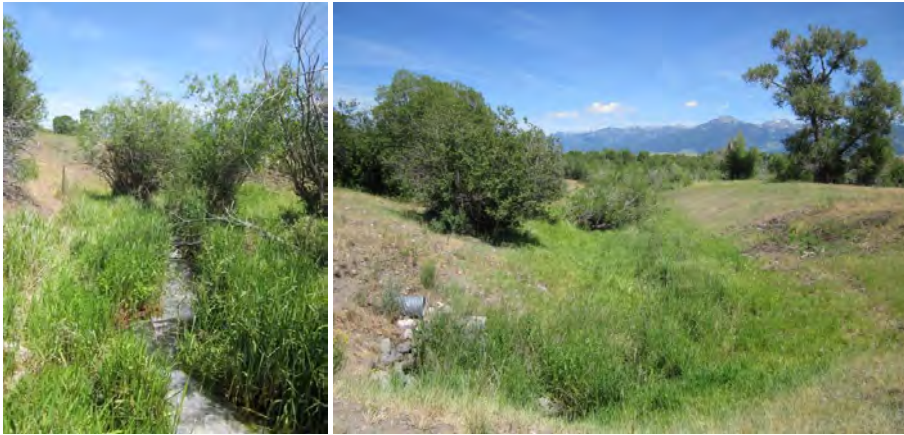
Kyrsten Wolterstorff visited the project site on June 30, 2017 and was accompanied by the landowner, who has had considerable interest in the success of this project. The step/pool sequence was still present and appeared unchanged since its post-construction condition (Figure 62). In addition, the siphon conveying North Fork Fridley Creek under the Park Branch Canal was still in place and remained at the constructed grade. Although not part of the FFIP grant, the landowner had installed a hotwire fence to exclude livestock. The riparian area was in excellent condition, with cottonwoods, alders, willows, and sedge-lined banks. The streambed was a mix of silt and gravels, although silt comprised most of the particles. On a subsequent visit on July 24, 2017, Krysten found three redds, and this timing coincided with the Yellowstone cutthroat trout spawning period.

**FIGURE 62. NORTH FORK FRIDLEY CREEK DOWNSTREAM OF SIPHON UNDER PARK BRANCH CANAL (L) AND EMERGING FROM DOWNSTREAM END OF SIPHON UNDER PARK BRANCH CANAL (R).**

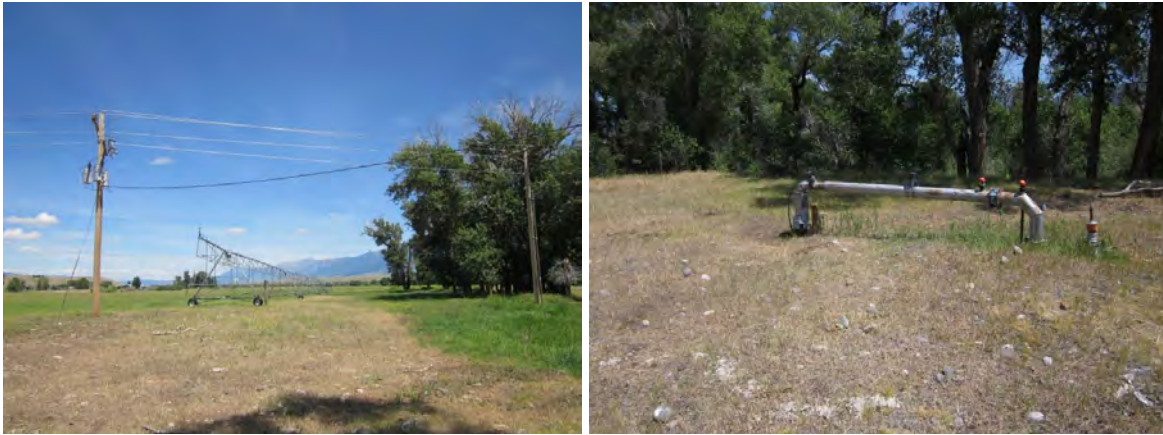
The water savings portion of the project was also implemented and still being used. Aerial photos show the center-pivots and location of the well that supplied the pivots with water (Figure 63). On-the-ground observations further confirmed the presence of the irrigation system installed to replace water diverted from North Fork Fridley Creek (Figure 64).

**FIGURE 64. CENTER PIVOT INSTALLED AS A WATER SAVINGS MEASURE FOR NORTH FORK FRIDLEY CREEK (L) AND PUMPING STATION SUPPLYING WATER TO CENTER PIVOTS (R).**

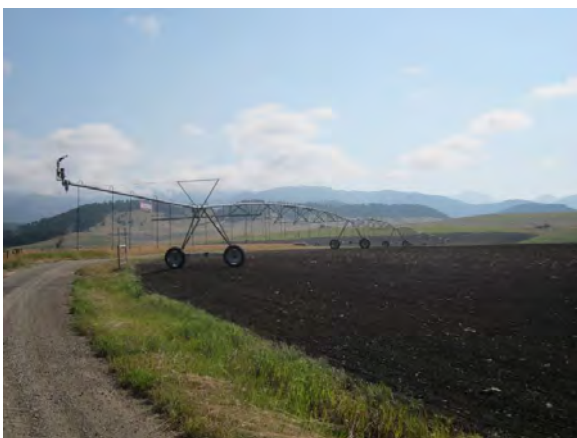
On June 22, 2017, Kyrsten Wolterstorff visited the project site. The center pivot was in place and being used to irrigate a hay pasture (Figure 65). Although not photographed, the pipe diverting water to the center pivot was in place at the fish screen (North Fork Horse Creek fish screen (022-04)) and delivering water through the pipe eliminated evaporative water loss or seepage.

**FIGURE 65. CENTER PIVOT NEAR NORTH FORK HORSE CREEK.**

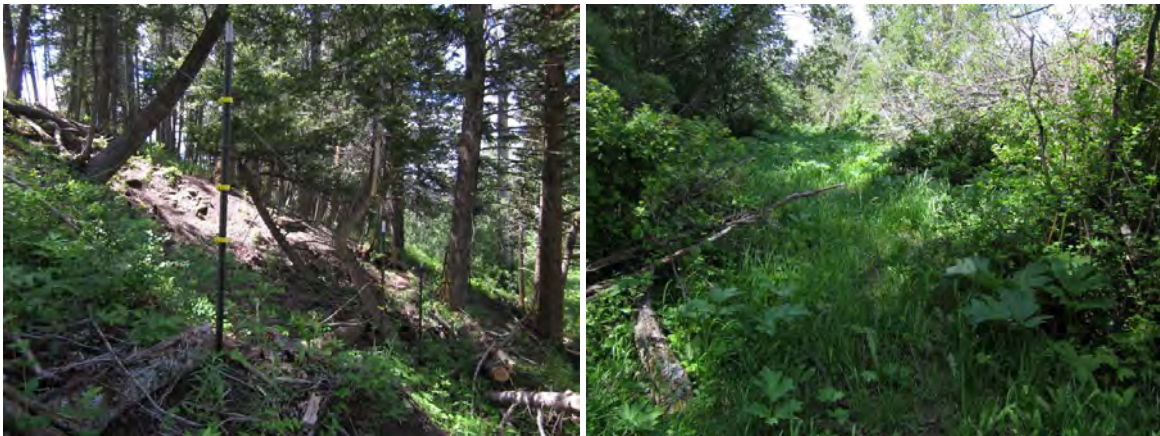
On June 22, 2017, Kyrsten Wolterstorff and Carol Endicott visited the property to determine if the fencing had been installed and evaluate the condition of the stream and riparian area. A robust fence had been constructed down-gradient from the bench and was an effective barrier to livestock (Figure 68). This hillslope showed no evidence of disturbance by livestock. This area had a dense, coniferous overstory, with a robust understory of herbaceous vegetation and mixed-aged shrub community.

**FIGURE 68. NEW FENCE INSTALLED TO PREVENT LIVESTOCK FROM ACCESSING NORTH FORK HORSE CREEK FROM BENCH (L) AND TYPICAL VIEW OF THE FENCED OFF HILL SLOPE PROTECTED BY FENCING INSTALLED ALONG THE TOP OF THE BENCH (R).**

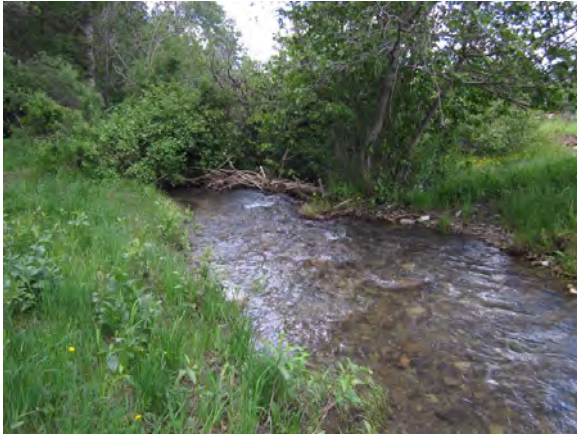
North Fork Horse Creek apparently benefited from reduced disturbance from livestock accessing the stream from the bench. The stream was a healthy foothills stream with a gravel streambed, stable banks, and a robust riparian area vegetated with sedges, forbs, and dense shrubs (Figure 69). The

opposite bank is under different ownership, and the residence is relatively close to the stream. This residential reach lacked a dense shrub community; however, herbaceous vegetation maintained bank stability, and the stream channel was stable. The conditions on the cross-stream neighbor's property had improved with implementation of the project.

**FIGURE 69. TYPICAL VIEW OF NORTH FORK HORSE CREEK IN REACH PROTECTED BY FENCE INSTALLED ON THE BENCH.**

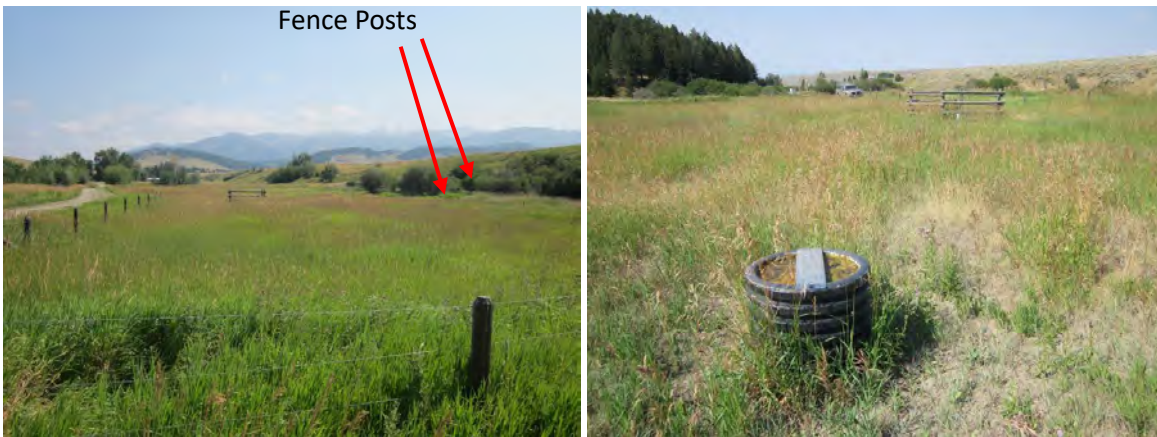
Fencing and installation of off-channel stock water had a positive effect on the riparian pasture at the downstream end of this property. Tall grasses within the pasture obscure much of the riparian fence; however, posts are visible at several locations (Figure 70). This photo replicates a pre-project photo. Indicators of improvement in the health of the riparian area include an apparent increase in density of willows, and the existing willows no longer have the umbrella-shaped morphology typical of grazed riparian areas. With exclusion of livestock from the riparian area, an alternative source of stock water was required. Kyrsten noted 2 automatic waterers within the fenced area. Combined, the fencing and off-stream water supply are complementary best management practices for sustainable livestock production adjacent to streams.

**FIGURE 70. PASTURE AT DOWNSTREAM OF PROPERTY WITH RIPARIAN FENCING (L) AND OFF-STREAM STOCK WATERER (R).**

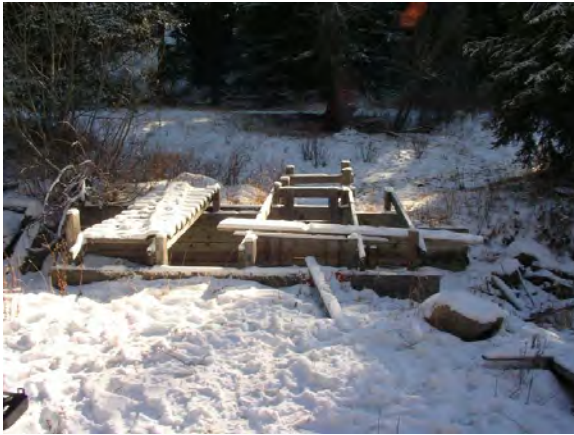
The goal of this project was to increase water use efficiency and prevent entrainment of nonhybridized Yellowstone cutthroat trout into an irrigation system on North Fork Horse Creek. The existing diversion was a wooden pin and plank structure that delivered water to an open ditch (Figure 71). Diversions that closed with check boards are notoriously leaky. Moreover, the ditch was an inefficient mode of delivering water, as it leaked and loss water to evaporation.

**FIGURE 71. PIN AND PLANK IRRIGATION DIVERSION ON NORTH FORK HORSE CREEK.**

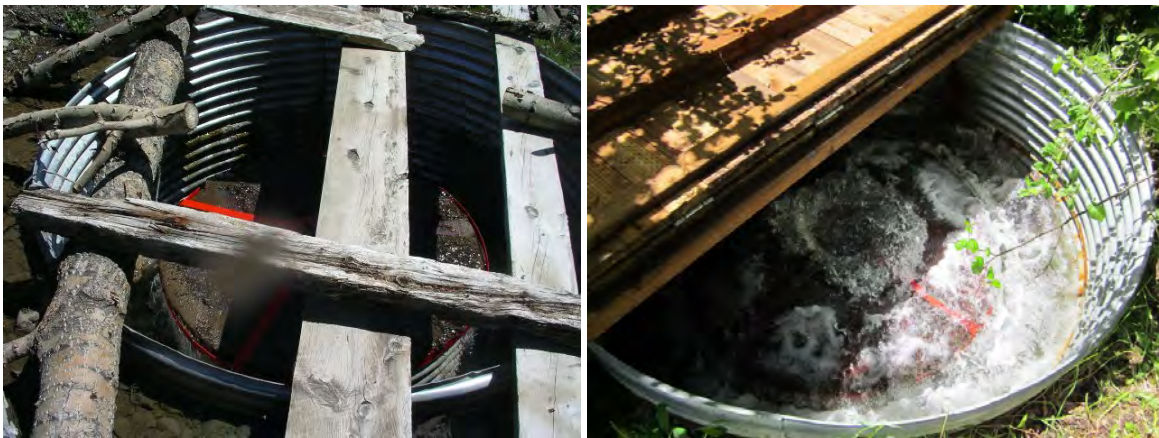
The fish screen on North Fork Fridley Creek has been visited several times. On August 11, 2010, Carol Endicott viewed the screen while it was not in use. Some detritus had settled on the face of the screen, but no fish were impinged. The detritus may have collected as the irrigation ceased for the season and flows decreased. The absence of dead fish on the screen suggested the turbulence was sufficient to flush fish off the screen. In addition, no dead fish were present in the tank surrounding the fountain, indicating the bypass pipe has sufficient draw to move fish back to the stream.

**FIGURE 75. TURBULENT FOUNTAIN SCREEN WHEN NOT IN USE (L) AND IN USE (R) ON NORTH FORK HORSE CREEK.**

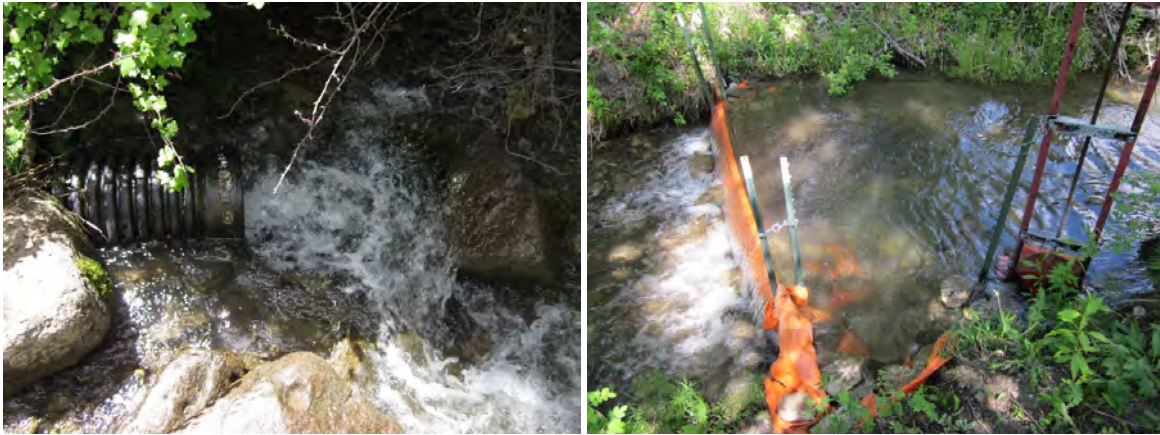
On June 22, 2017, Kyrsten Wolterstorff and Carol Endicott checked on the function of the screen. The turbulence was substantial and appeared to be sufficient to move detritus and fish off the screen. A substantial amount of water flowed through the bypass pipe (Figure 76). The check boards were in place and were likely a temporary barrier to fish movement.

**FIGURE 76. BYPASS PIPE (L) AND CHECK BOARDS IMPOUNDING FLOWS TO DELIVER WATER TO THE HEAD GATE (R).**

The potential for the check boards to block fish movement is another consideration. According to the FFIP application, the previous diversion had been a total barrier to fish movement. The difference with the current checking of water is that the duration of diversion was decreased by a month as a condition of funding. Instead of diverting from May 1 through July 15, the water user agreed to restrict use to May 1 through June 25, with a 10-day period of use after July 15. This timing coincides with the spawning period for Yellowstone cutthroat trout. However, flows may not be checked during much of the spawning period, as it coincides with spring runoff, when flows are elevated.

Recommendations for this project, along with the complementary actions of water savings and riparian fencing, address the opportunity to evaluate the response of the Yellowstone cutthroat trout population in North Fork Horse Creek to the cumulation of conservation actions. A follow-up fish survey would be informative. Likewise, installing a trap at the out flow of the bypass pipe on the fish screen would be useful in evaluating if fish are being bypassed, and if the screen causes injury.

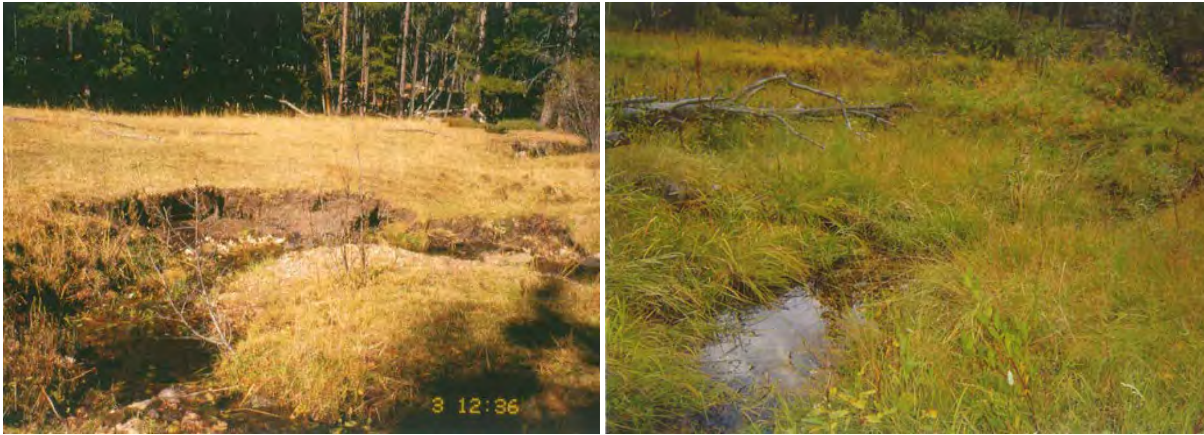
Available information includes pre-project photo points from 1996, matched with follow-up photos from 2005. The stream and riparian area had recovered substantially with installation of riparian fencing. Vertical eroding banks had stabilized with dense stands of sedges and willows (Figure 77). Although seasonality can bias interpretation of the photos, the stream and riparian area had recovered substantially. Herbaceous vegetation was closely cropped in the pre-fencing photo but was tall and dense after 8 years of rest. A second pair of before and after photos showed similar recovery following exclusion of livestock, with banks not showing signs of trampling, and riparian shrubs being more robust and dense (Figure 78).

**FIGURE 77. PRE- AND POST-FENCING PHOTOS TAKEN ON A MEANDER BEND ON RICHARDSON CREEK, 1996 (L) AND 2005 (R).**

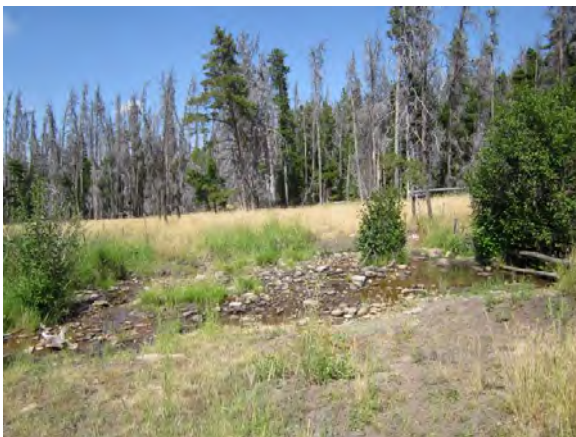
On August 3, 2017, Kyrsten Wolterstorff visited the restoration project on Richardson Creek. GPS data indicated she examined the entire length of the fenced area. The riparian exclosures were still in place, and a healthy riparian area and stable stream channel were present within the fenced area (Figure 79). A water gap between fenced areas showed indications of heavy use by livestock (Figure 80)

**FIGURE 80. WATER GAP BETWEEN FENCED REACHES ON RICHARDSON CREEK.**

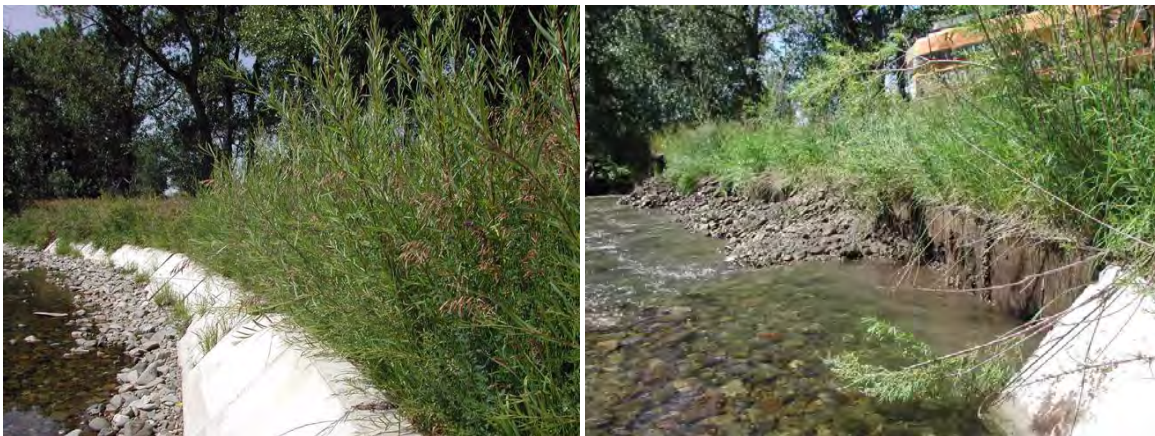
**FIGURE 83. STABILIZED BANK ON THE SHIELDS RIVER (L) AND REMOVAL OF CONCRETE BLOCK AND INSTALLATION OF ROCK TOE (R).**

Photos illustrating the removal of the concrete barriers show the barrier left a bare, vertical bank. The nonnative agricultural grasses did not provide the root mass typical of riparian species, which promote soil cohesion and resilience against erosion. A cobble toe was clearly installed as part of the project, although this action was not described in background materials or the project budget.

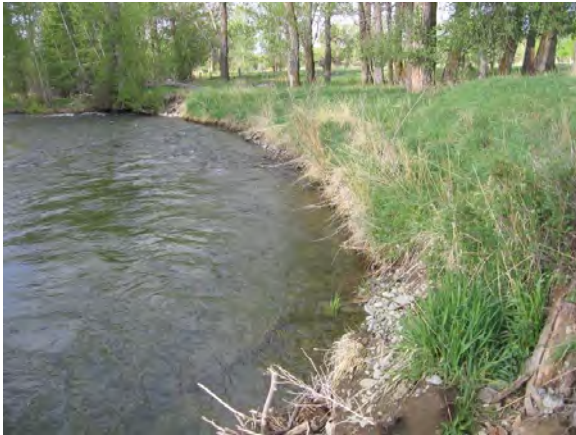
Background information includes photos that were apparently taken several years after removal of the concrete blocks (Figure 84). Willow survival was negligible, although the nonnative grasses had colonized the constructed floodplain. Remnants of the installed rock toe were still visible, but much of it had apparently been washed away, leaving undercut banks. As shallow-rooted, nonnative grasses line the banks, the long-term stability of this bank is questionable.

**FIGURE 84. POST-PROJECT PHOTO DATED 2007**

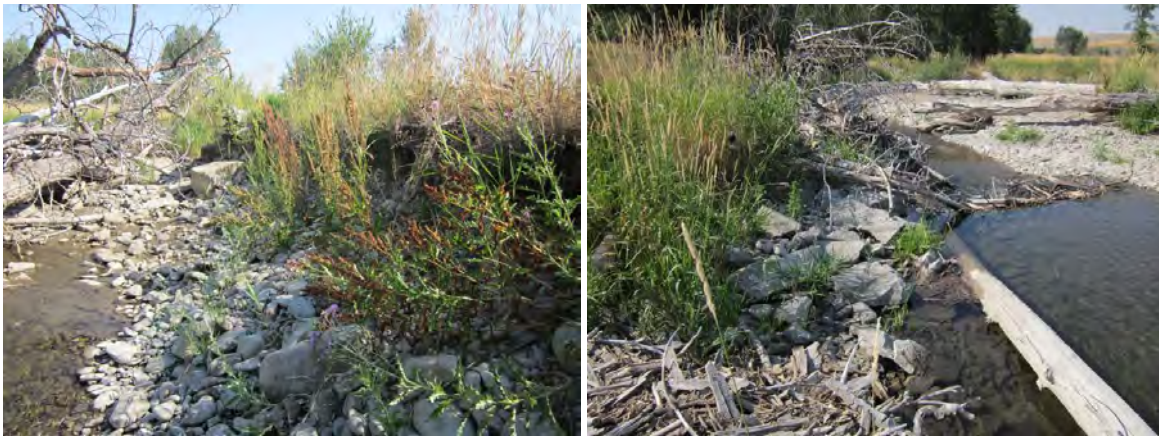
On August 22, 2017, Kyrsten Wolterstorff and Carol Endicott visited the project site. As noted, determining the bank that had been treated was problematic. A portion of the bank considered most likely to be the treated bank supported a community of nonnative grasses and Canada thistle (Figure 85). A cobble toe was present, as opposed to the raw dirt that was present before treatment. Nevertheless, the bank had receded several feet. Large woody debris had been deposited at the site and was providing bank protection. More aggressive efforts at bank stabilization were apparent with riprap being present at the downstream end of the bank.

**FIGURE 85. STREAM BANK POTENTIALLY BEING THE RESTORED BANK (L) AND BANK ARMORING AND LARGE WOODY DEBRIS (R)**

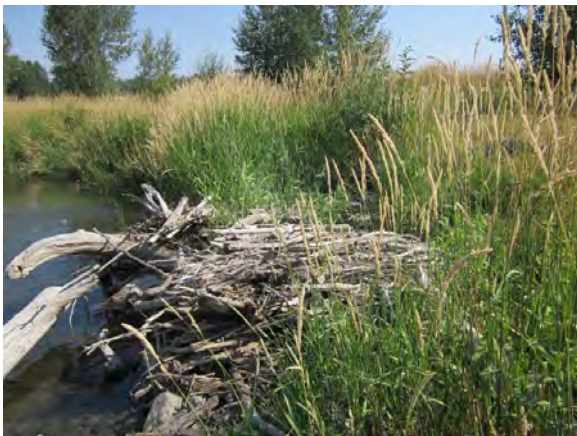
Looking upstream at the putative restored bank, reed canary grass had invaded the riparian area (Figure 86). This nonnative species is exceptionally invasive and hard to control. Although it functions to maintain bank stability, it does not provide the same ecological values as a native shrub community.

**FIGURE 86. REED CANARY GRASS INFESTATION ALONG PUTATIVELY RESTORED BANK.**

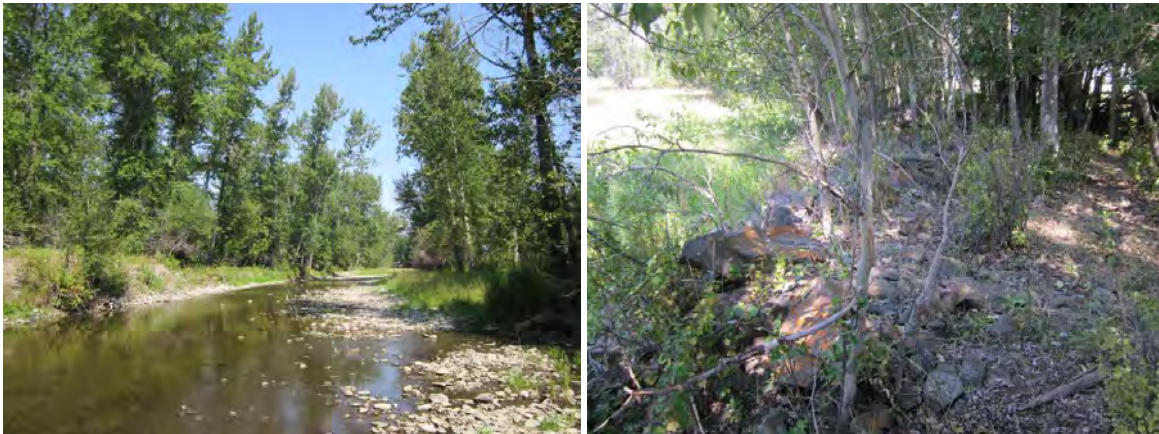
The Shields River flows through a cottonwood gallery forest and is single thread throughout the property (Figure 96). An old attempt at bank stabilization using riprap was only partially protecting the stream, as the channel had moved away from a considerable length of the applied rock. Although not locally derived, the streambed was heavily silted throughout the reach (Figure 97). The Shields River is

**FIGURE 96. TYPICAL VIEW OF PROPERTY 2 (L) AND OLD RIPRAP THAT WAS NO LONGER NEAR THE CHANNEL.**

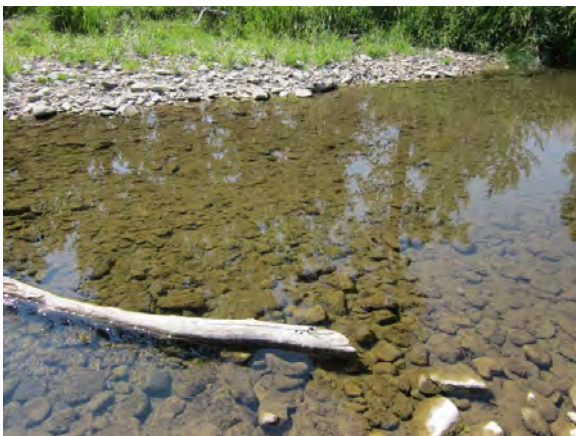
listed as impaired for siltation by the Department of Environmental Quality, and the watershed group has a plan to reduce sediment loading from bank erosion, hill slope erosion, and roads.

**FIGURE 97. SILTATION OF THE SHIELDS RIVER'S STREAMBED.**

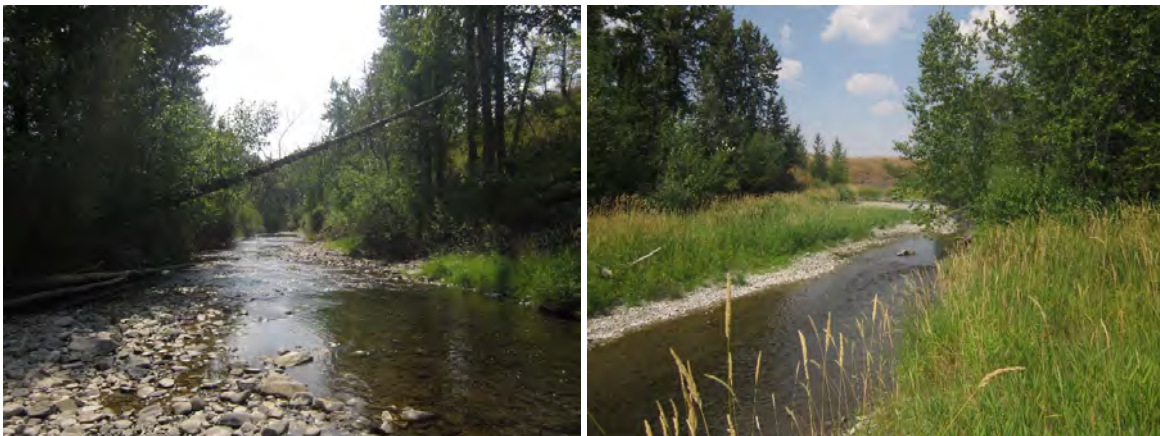
**FIGURE 99. SHIELDS RIVER WITH MIXED CONIFER AND COTTONWOOD OVERSTORY (L) AND INFESTATION OF REED CANARY GRASS (R) ON PROPERTY 3.**

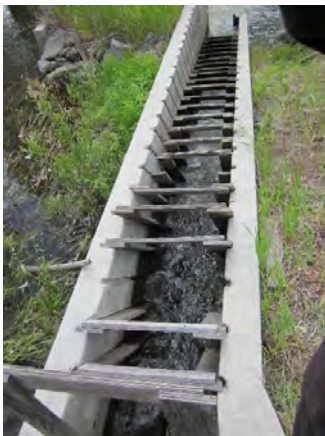
the fish ladder. The Denil fish ladder was designed according to the established standard, with closely spaced baffles that create turbulence that dissipates energy. Visual inspection of the ladder found highly turbulent water; nevertheless, the velocity appeared to be substantial in the ladder and may exceed the burst swimming ability of fish. Other observations were that cobbles had embedded the baffles, which are now immobile. In addition, the baffles are wooden and have swollen. Digging out the cobbles or using a mechanical winch may be advisable to reset the baffles. A second set of baffles is stored at the Livingston Fisheries Office; however, metal baffles may be an improvement, as they would not swell, and may be easier to extract in cleaning the ladder, despite their greater weight.

**FIGURE 102. DENIL FISH LADDER ON SOUTH FORK FRIDLEY CREEK.**

Recommendations include clearing the cobble and removing the baffles to check their condition. Another set can be installed if they are damaged. In addition, personnel with expertise in fish passage should evaluate if the ladder is passable in its current condition.

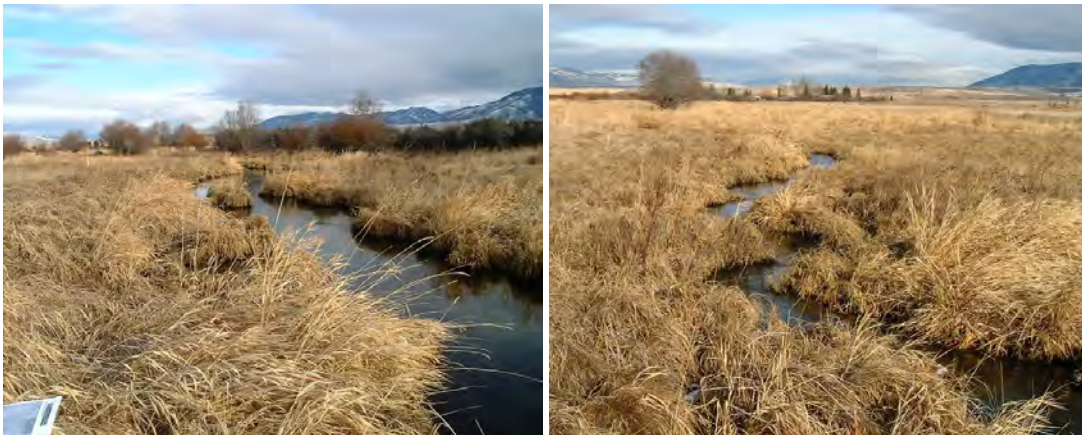
Photos presumably of the unnamed tributary show sedge covered stream banks and variability in channel width (Figure 104). Willows were rare to absent along the channel. Formation of a sedge covered, mid-channel bar suggested insufficient energy to maintain a narrow, deep E channel that is typical of spring creeks.

**FIGURE 104. UNLABELED PHOTO POTENTIALLY SHOWING UNNAMED TRIBUTARY.**

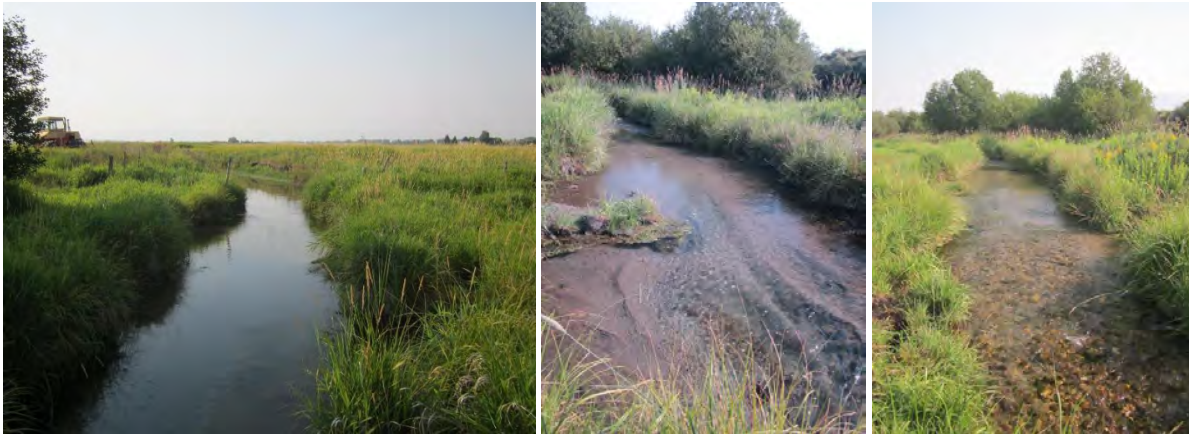
On August 4, 2017, Kyrsten Wolterstorff visited the South Fork Ross Creek project site, accompanied by the landowner. The channel had reverted to its overly wide configuration, and accumulation of fine sediment was again substantial (Figure 105). A robust stand of undisturbed sedges occupied the bank line, so lateral adjustments were not the result of bank erosion. Fine sediment did not fill in the entire channel, as a discrete reach maintained clean gravel (Figure 105).

**FIGURE 105. OVERLY WIDE CHANNEL (L), ACCUMULATION OF FINE SEDIMENT (C), AND EXPOSED GRAVEL (R) ON RESTORED PORTION OF SOUTH FORK ROSS CREEK.**

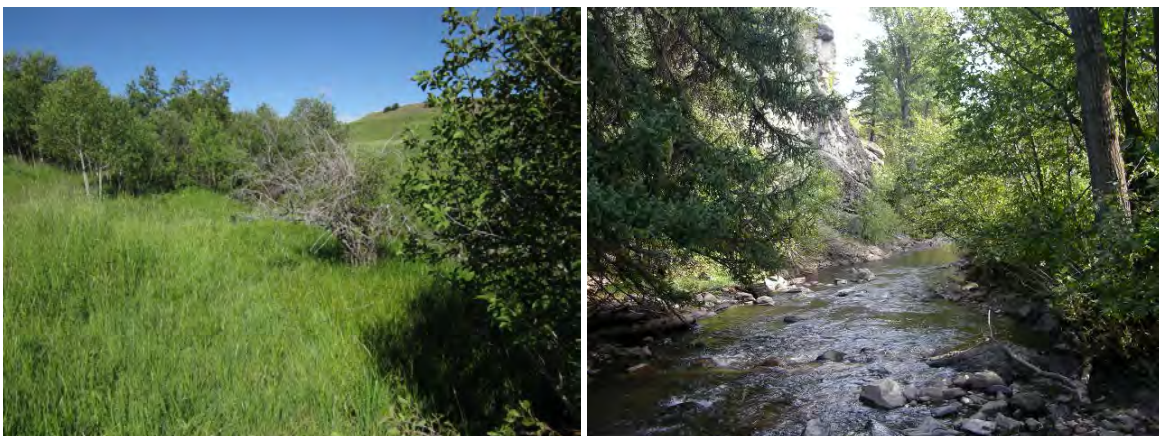
Subsequent electrofishing efforts indicated Yellowstone cutthroat trout did not stay in Thiel Creek. Thiel Creek is a small, gravel-bed stream flowing through rangeland (Figure 107), and Lower Deer Creek is a montane stream with a predominantly cobble substrate (Figure 107). As the habitat in Thiel Creek was considerably different than Lower Deer Creek, the Yellowstone cutthroat trout likely left. Efforts to establish or reestablish Yellowstone cutthroat trout since this project has used egg boxes or remote site incubators, so fry become imprinted on the new stream.

**FIGURE 107. TYPICAL VIEW OF THIEL CREEK UPSTREAM FROM THE CONSTRUCTED BARRIER (L) AND OF LOWER DEER CREEK (R).**

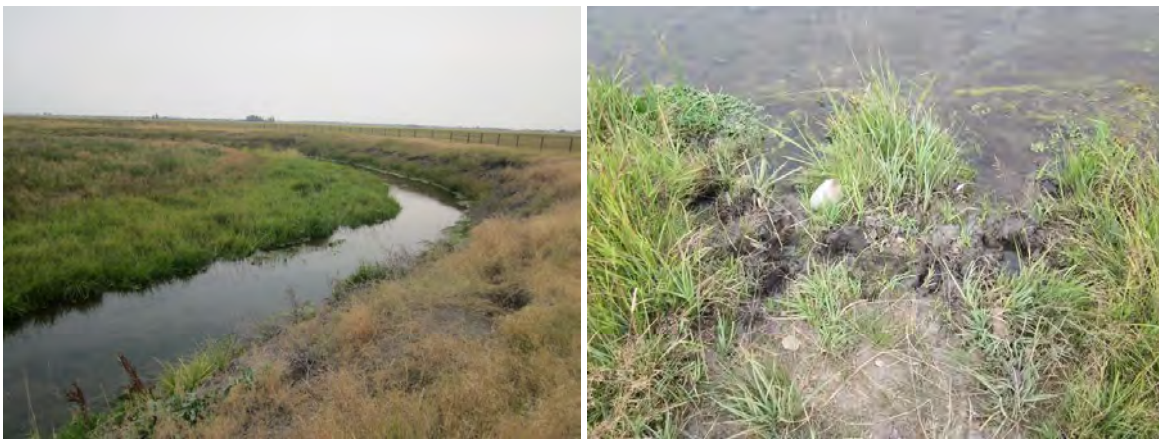
Kyrsten Wolterstorff visited the Thompson Creek project on August 8, 2017. The riparian area was fenced (Figure 110), although not according to the FFIP application. Some hoof shear and manure were present, but grazing pressure was otherwise light.

**FIGURE 110. RIPARIAN FENCING (L) AND SLIGHT TRAMPLING BY LIVESTOCK (R) ON THOMPSON CREEK.**

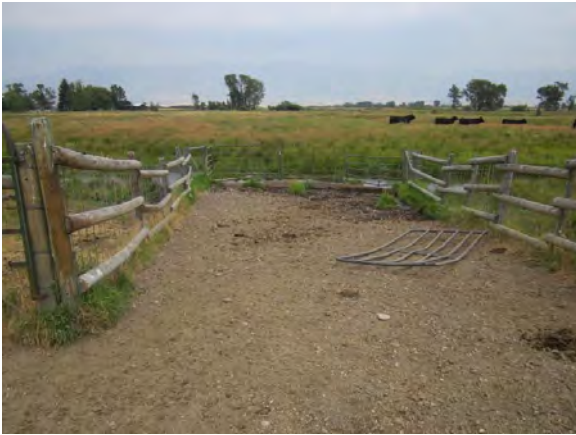
Armored water gaps had been installed as described in the FFIP application (Figure 111). Although it was unclear if the grazing followed a developed grazing management plan, the combination of fencing, water gaps, and limited use of the riparian area resulted in dense herbaceous vegetation within the riparian area. Shrubs were sparse to absent; however, many spring creeks do not provide habitat suitable for establishment of riparian shrubs.

**FIGURE 111. ARMORED WATER GAP ON THOMPSON CREEK.**

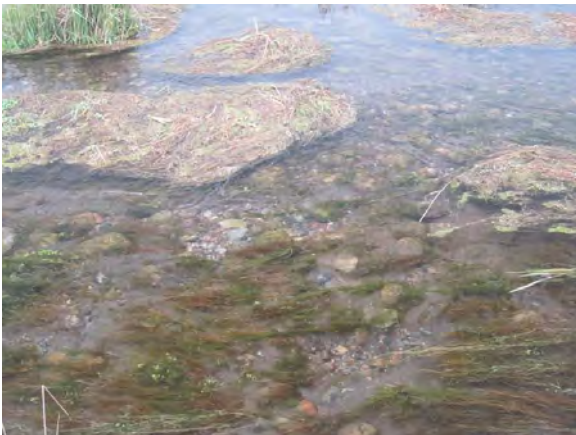
The amount of fine sediment choking the streambed was a factor limiting the ability of Thompson Spring Creek to meet project goals of providing spawning habitat for fish migrating from the East Gallatin River (Figure 110 and Figure 112). The channel was relatively shallow and wide. Combined with the buffered flows typical of spring creeks, the stream lacks the energy to transport fine sediment from its bed.

**FIGURE 112. THOMPSON CREEK'S STREAMBED, SHOWING HIGH LEVELS OF FINE SEDIMENT AND SPARSE GRAVEL.**

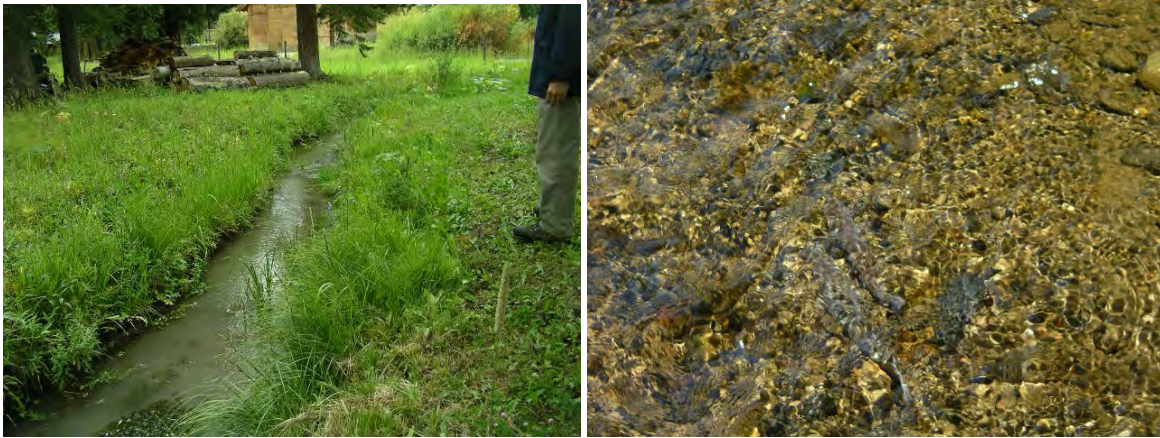
**FIGURE 114. REACH OF WILLOW CREEK USED FOR SPAWNING (L) AND SPAWNING YELLOWSTONE CUTTHROAT TROUT.**

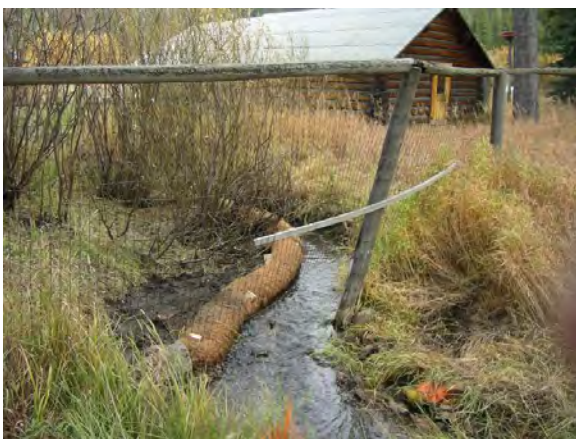
The restoration approach was to excavate the channel 1-ft deeper than the desired bed elevation, construct a narrow and deep channel, using straw wattles at the edge of the banks. The muck excavated from the existing channel was placed behind the wattles and planted with container stock of sedges and rushes (Figure 115). Much of the muck substrate appeared to be soot delivered from the surrounding hillsides after the 1988 wildfires. Spawning size gravel was imported to the stream, and was one foot deep, providing substantial depth for Yellowstone cutthroat trout to dig redds. Several culverts were replaced with larger, squashed pipes to improve flow and sediment conveyance. Restoration occurred in May of 2013.

**FIGURE 115. NEW BANK BUILT WITH STRAW WATTLE AND BACK FILLED WITH SEDIMENT EXCAVATED FROM CHANNEL.**

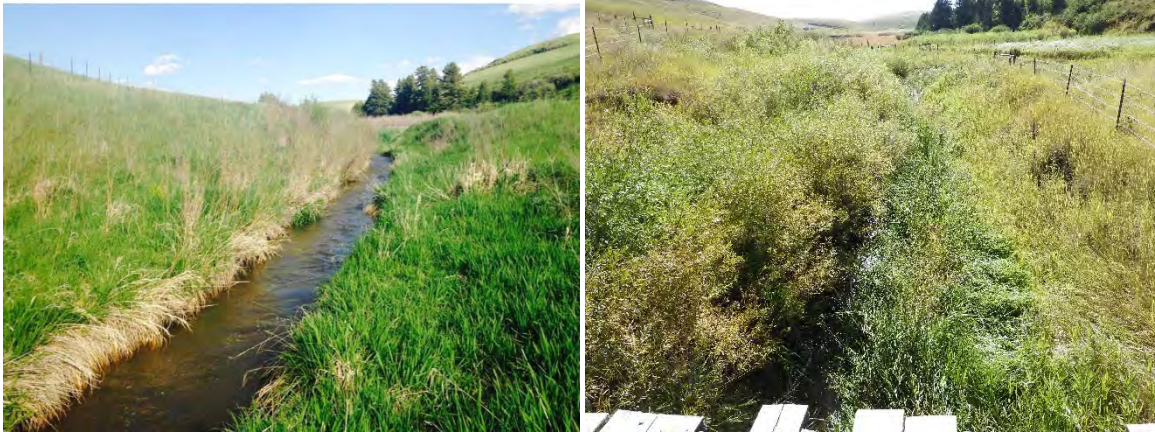
The area has recovered significantly. Soil was added the bridge to encourage cattle to cross, which has been successful.

**FIGURE 118. BIG OTTER CREEK RIPARIAN RESTORATION BEFORE (L) AND AFTER (R) RESTORATION.**

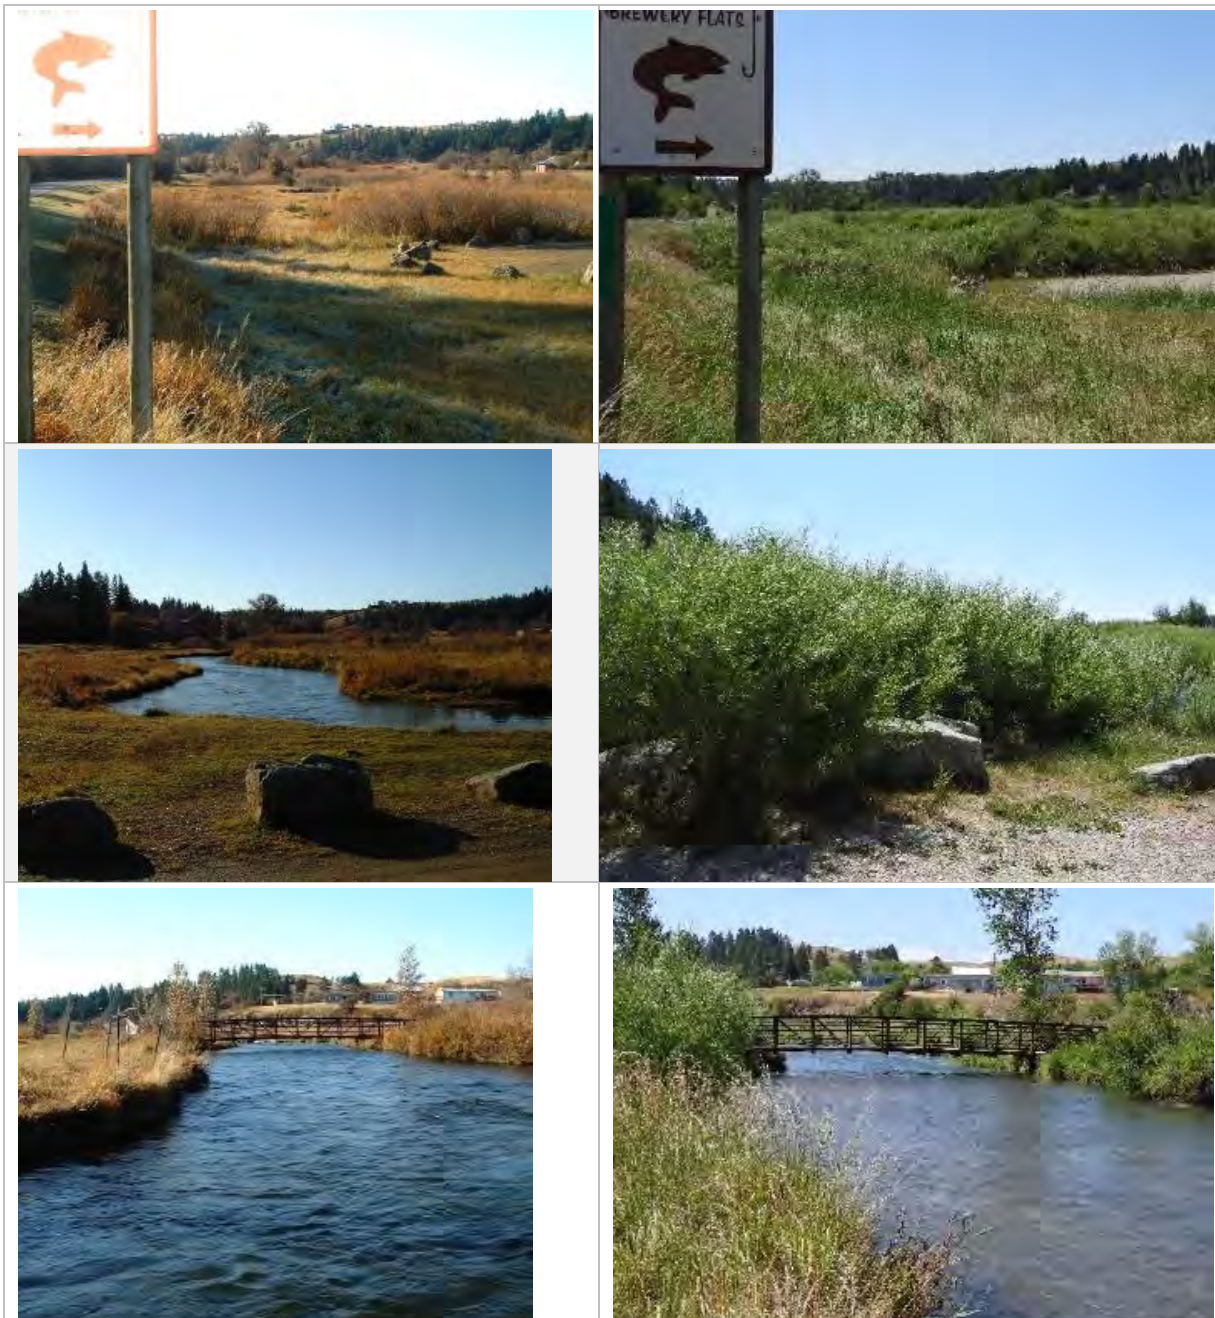
Monitoring in 2017 showed considerable willow growth (Figure 119). Some riparian enclosures were in place, but natural recruitment is having the highest success rate. The stream had only minor adjustments after 17 years. Some lateral erosion was present near a walking trail bench, but minimal overall. The project has been very successful in its goal to reconstruct the stream to its natural channel and establish natural riparian vegetation. This project site is public and used for walking, bicycling, bird watching, and angling. It is the ideal project for the FFIP: angling opportunities and fisheries habitat have increased substantially.

**FIGURE 119. EFFECTIVENESS MONITORING PHOTOS AT BREWERY FLATS. AFTER CONSTRUCTION (2009, L) AND CURRENT (2017, R).**
